Zinsco Electrical Panel Advice for Homeowners and Home Buyers

Zinsco Panel Field Failure Reports

Zinsco Electrical Panel & Breaker Test Results

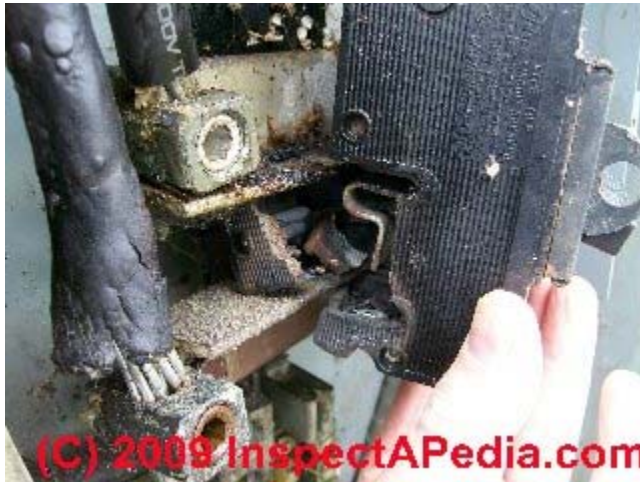
Limited test results reported by [J. Aronstein](#) indicate that the central Zinsco electrical panel and circuit breaker failure problem appears to be burnups at the clip-to-bus connections such as shown in our photo of a burned Zinsco electrical panel bus and breaker. The few circuit breakers tested by Dr. Aronstein were reported to trip within normal overcurrent limits. However a circuit breaker whose bus connection burns can lead to overheating damage to the circuit breaker itself, rendering it non-functional.

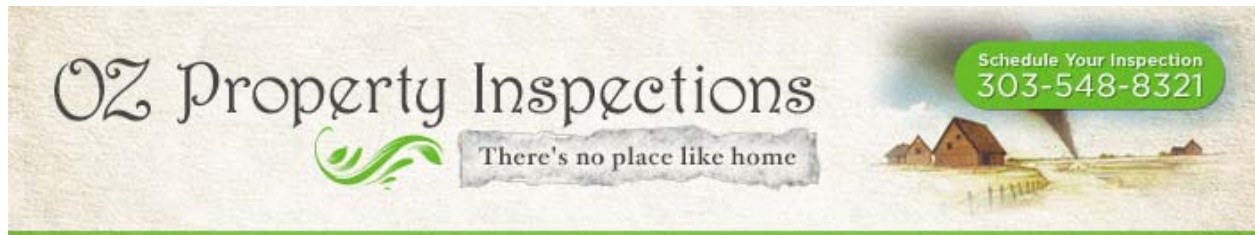
Photo (left) of a burned and failed Zinsco main circuit breaker, courtesy of [J. P. Simmons](#) - Mr. Electric. Simmons adds: "In this case the failure damaged the main wire to a mobile home also (you can see the melted wire to the left of the main). This is a

good example of why I do not like to see anyone remove these breakers. You can not tell how bad they are damaged by looking at them.

Where Zinsco and Zinsco-Sylvania electrical panels are discovered in buildings they should be replaced to reduce some very real fire and shock hazards.

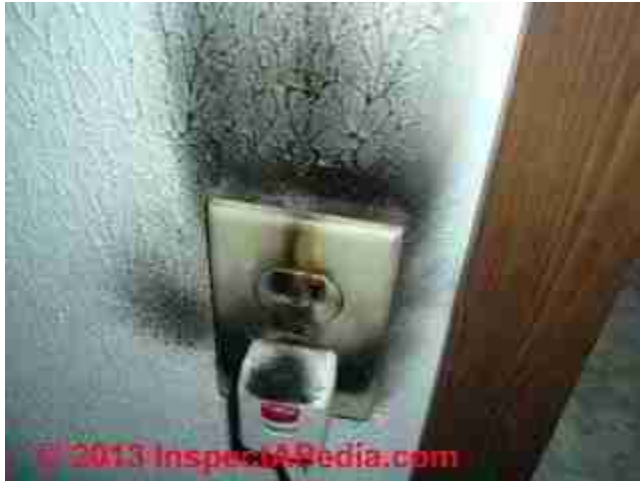
Our photo (above left) illustrates a burned-up electrical receptacle whose circuit was *protected* by a Zinsco circuit breaker that failed to trip and in fact had burned itself in the panel.

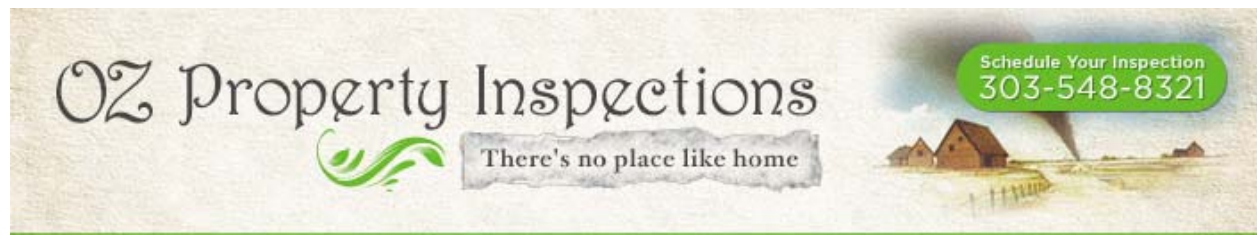
A principal Zinsco™ circuit breaker (or Sylvania™ or GTE-Sylvania™ or Kearney™ electrical panel using this circuit breaker) point of failure appears to be at the point of contact where the circuit breaker contacts clip onto the electrical panel bus, combined with the use of an aluminum electrical panel bus.

As described at [ZINSCO FAILURE REPORT PROCEDURE](#), expert testing on this equipment has shown that circuit breakers do not trip about 25% of the time when exposed to overcurrent - risking overheating, fire and other hazards. The failure rate of competitive-brand circuit breakers is much less than 1%.
